# THE WITTERN GROUP, INC.

NO: 2001-02

## BULLETIN

**SUBJECT:** CB700, CB300-SA, & CB300-SATL  
Models 3151, 3172, 3172A, 3179, 3179A  
Can/Bottle Vendor

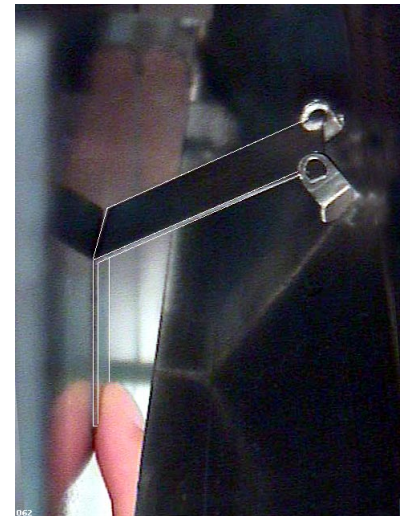
Figure 3. Correct  
No adjustment needed.

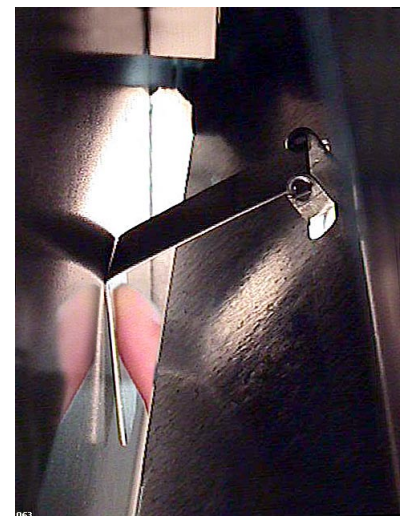
**SYMPTOM:** Double vending of cans.

Figure 4. Wrong  
Adjustment needed

To bend back, place one finger on the backside of the bend and push against it using the fingers of your other hand. Bend only at the bend-line to keep the bottom half of the part flat.

To bend forward, pull it forward against the stop and push. Bend only at the bend-line to keep the bottom half of the part flat.
