Alpine Elevator ST5000E Model 3561

Mismatch of Tooth Profiles between Timing Belt & Pulley

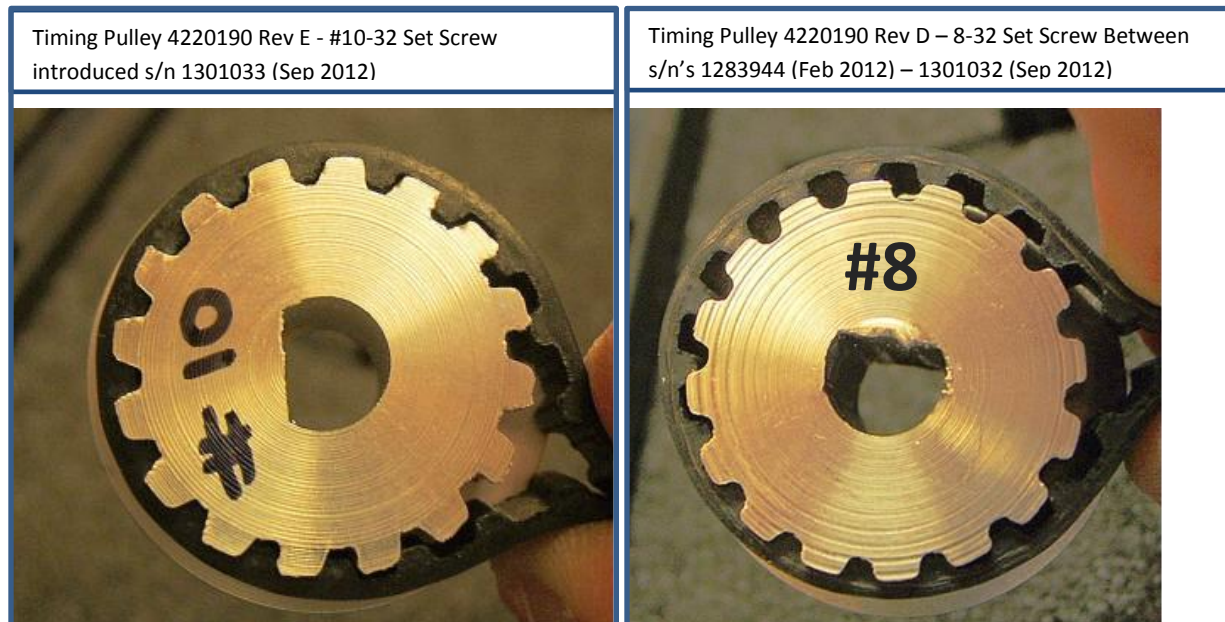
Elevator bucket is leveled and 20-30 vends later the bucket has skewed/gone off the level again to the point that the top limit switch is no longer actuated and the elevator stops at the top and remains there. The same can happen in the other direction, it will probably continue to operate but look very strange.

Whilst the pulley & belt mating parts are classified the same e.g. the correct pitch between teeth, the trapezoidal tooth profiles do not match, this can result in the belt ratcheting on the pulley, which can & does cause the two belts to go out of sync with each other if the belt tension is not equal:

If receiving field report from machines that fall between serial numbers 1283944 - 1301032 that the elevator bucket is repeatedly skewed/gone off the horizontal then both the 4220190 Timing Pulley's should be replaced.
