GENEVA COFFEE

Top Chamber Seal Adjustment

Too Long or Too Short?

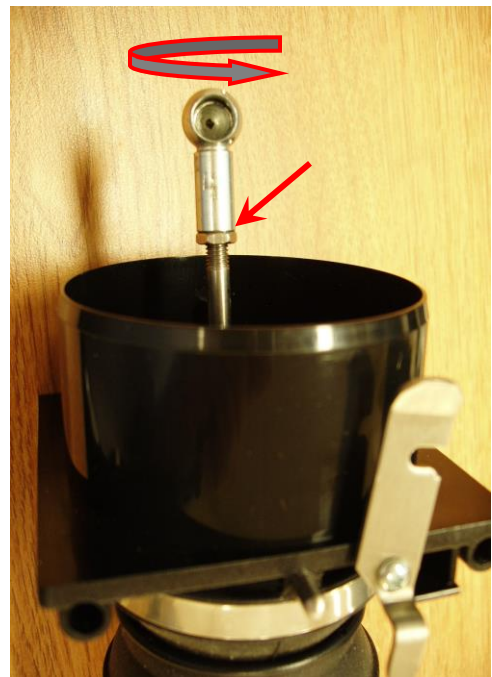
1. If the length of the seal rod is too short, the opening between the top bowl and the brew chamber is too small for the loose ground coffee to pass through; the result, that may be intermittent, is that some of the coffee/water passes through to the brew chamber and some remains in the top bowl, the coffee delivered to the cup will therefore be a short measure. At the end of the cycle when the cylinder is lifted the remaining coffee/water will quickly pass through to the filter plate at the base, splash and make a mess.
2. Conversely, if the rod is too long, the seal will not make an airtight seal and therefore the brew cylinder will not be sufficiently pressurized to force the coffee brew out of the cylinder. The result of this is identical to the 'too short' scenario above.

Procedures for Both Cases:

1. Hold the top coupling firmly slacken-off the lock-nut
2. a) If coffee & water is holding in the top bowl, hold the seal rod and 'unscrew' the coupling 1 full turn **anticlockwise** as shown

b) If the coffee & water is passing through from the top bowl to the brew chamber OK, but there is an air leak between the top bowl and the brew chamber (can be checked using a flashlight and observing bubbles when doing a brewer flush); hold the seal rod and 'screw-down' the coupling 1 full turn **clockwise**, opposite to the illustration shown
3. Hold the top coupling firmly and re-tighten the locknut
